The Collapse of the World Trade Center Towers: A Metallurgist's View

Frank W. Gayle

This article is based on an edited transcript of a presentation given by Frank W. Gayle (National Institute of Standards and Technology) on April 12, 2007, in Symposium X at the Materials Research Society Spring Meeting in San Francisco.

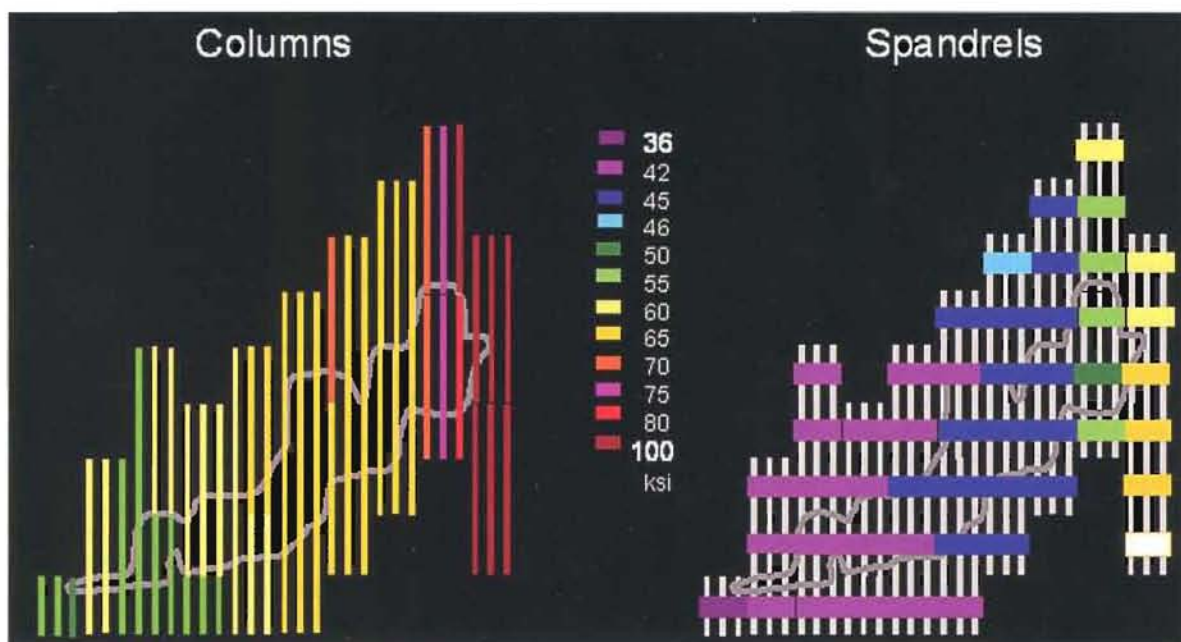
cated, asymmetric arrangement, the pattern being different for each of the eight sides of the two buildings. Figure 2 shows an illustration of the section of the South Tower (World Trade Center 2, the second to be hit and the first to collapse) that was struck by the aircraft, with the grades of steel in the columns and spandrels color-coded. In this one area alone, the aircraft entering the building hit all 12 grades of steel—this fact defined the scope of our analysis to include all of the grades of steel used in the building.

Figure 2. Grades, or strengths, of steel impacted by the aircraft on the south face of the South Tower (World Trade Center 2). All 12 grades of steel used in the perimeter panels were involved in the airplane impact.

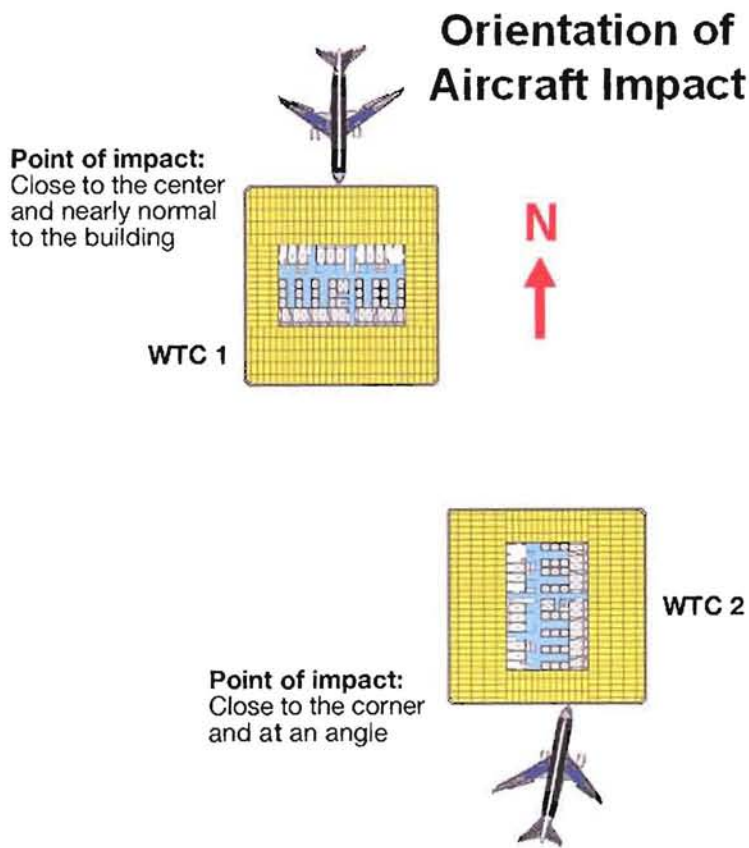
What did make a difference was the speed and orientation of the planes with respect to the buildings, particularly the core, as they impacted the towers (Figure 3). On the North Tower, the plane hit the very center of the north face and continued through, damaging the core, but in a very symmetric manner, and loads were redistributed across the damage in the center of the core. In the South Tower, the plane came in at an angle, and the rectangular core was oriented 90° relative to that of the North Tower. Upon entry, the plane destroyed the corner of the core, and because it damaged one of the massive corner columns, there was much less capability to redistribute loads within the core. This more extensive damage to the South Tower gave it less residual strength and caused it to collapse first. The hat truss then played a critical role, allowing loads from the damaged core columns to be transferred over to the adjacent side walls of the perimeter.

Figure 3. Aircraft impact angles and positions for the two towers. Damage to the South Tower (WTC 2) was more severe than to the North Tower (WTC 1), since a corner of the core was severely damaged, making it difficult for loads to transfer from severed columns to adjacent columns. In WTC 1, the plane was traveling approximately 440 mph; in WTC 2, 540 mph.

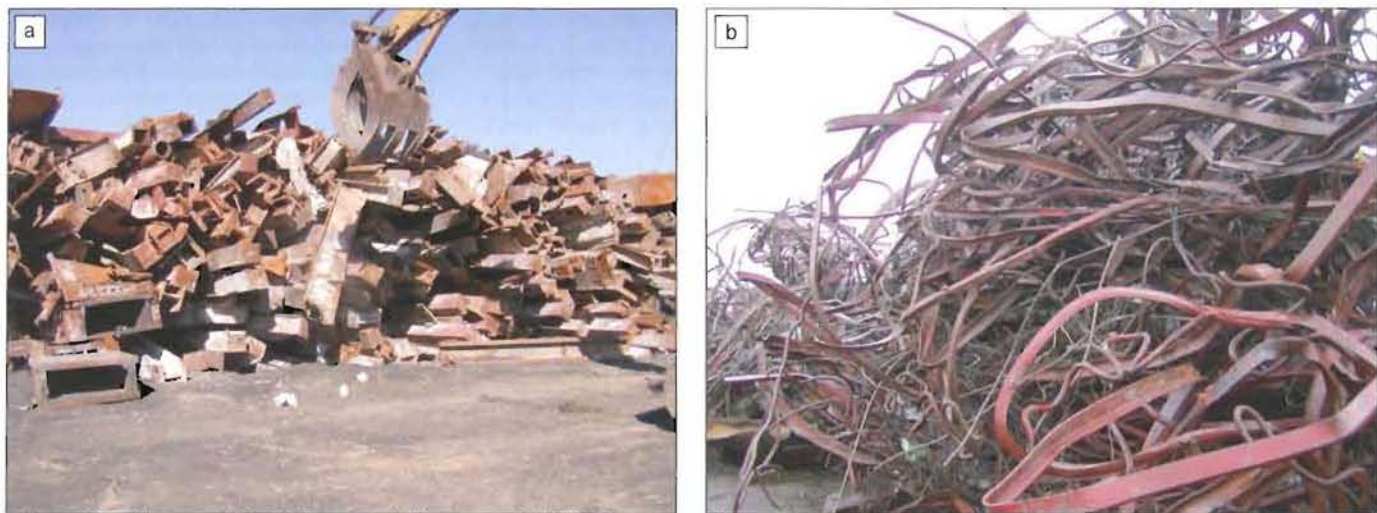
safely without causing injury. The steel was shipped to four salvage yards, one on Staten Island and three in New Jersey. Figure 4a shows the giant columns in the pile; the thought of extracting any useful pieces of steel out of that—particularly any specific pieces of steel—seemed rather daunting. The Structural Engineers Association of New York (SEAoNY) volunteered thousands of hours, both on the World Trade Center site and at the salvage yards, looking through the pieces. A member of the NIST team worked with SEAoNY in going through the steel, and even before we were officially charged with the investigation, potentially useful pieces of the steel were shipped to the NIST site in Gaithersburg, Maryland, for storage.

Materials arrived at NIST within a few months of September 11. Much of the steel was damaged but the amount of damage varied. Some of the column sections were in fairly good shape. In contrast, the floor truss materials, after being flattened in the collapse, had to be cut in pieces and balled up to get them off the collapse site

(Figure 4b), so they were not in very good shape by the time they were delivered to NIST. But overall, NIST got a very good selection of steel, including all 12 grades of the perimeter panels and four pieces from the north face of the North Tower that were directly hit by the nose of the airplane, the upper part of the fuselage, or the wings (see Figure 5). Identification was aided by serial numbers on the steel pieces in some cases and by the geometry of the plates used to fabricate the columns in others.

Figure 4. (a) Core columns, perimeter columns, and beams from the Twin Towers in a salvage yard in New Jersey. Critical pieces for the NIST investigation were recovered here. (b) Typical condition of the floor trusses in the salvage yards. The lightweight trusses were severely damaged during the collapse. Furthermore, since bridging trusses had been welded to the main trusses in a full-floor cross-grid system, the trusses had to be cut up and compacted in order to remove them from the collapse site.

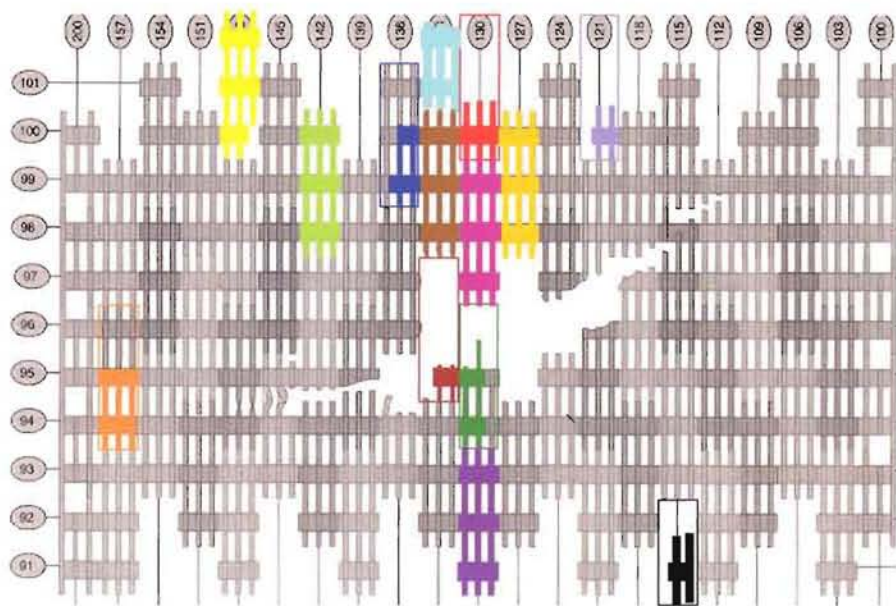
Figure 5. Map of the north face of the North Tower, showing perimeter column panels (in color) recovered and positively identified for analysis in the NIST investigation. These panels included four hit directly by the airplane, providing the opportunity to examine steel performance under high-speed impact. Other panels were used to establish baseline properties of the steel and performance under the high-temperature conditions expected in the fires.

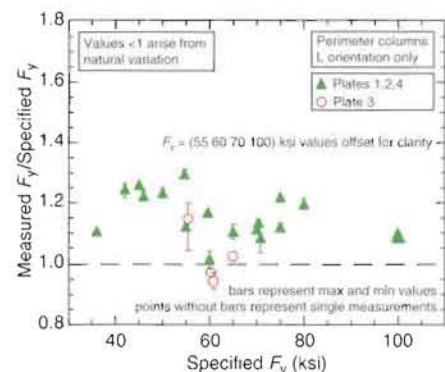
To answer some of those questions, Figure 6 shows a plot of the measured yield strength divided by the specified yield strength for the perimeter columns. Note that some strengths fall below the minimum values, but there are a number of innocuous reasons for that. During the

1960s, a fairly wide strength distribution was allowed in a production lot of steel. Also, once steel has been damaged even a slight amount, it loses an anomalous phenomenon called a yield point, and that will reduce the nominal strength by a few ksi. Finally, the original test procedures

Figure 6. Measured yield strength as a fraction of the specified strength for steel in the perimeter columns. Plates 1, 2, and 4 (triangles) were column panels, and plate 3 (circles) was a spandrel. Ratio values of less than 1 arose from natural variation in the steel and did not affect the safety of the towers on September 11, 2001.

could not be reproduced with the damaged steel, which again would result in somewhat lower test values. So, the observed values were not unexpected, and overall the quality of the column steel was determined to be acceptable.

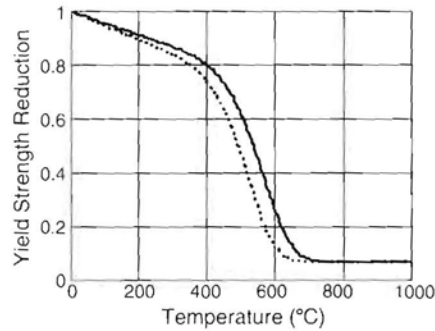
High-temperature behavior of the steel, of course, was a very important consideration in modeling building response to the fires. It is important to understand that the fires did not melt the steel; building fire temperatures typically do not get above about half the melting point of steel. However, steel loses strength at temperatures found in a fire, typically 400°C–700°C, depending on conditions. Figure 7 shows the dramatic drop in steel strength at high temperature. The NIST Materials Science and Engineering Laboratory provided models of each steel's behavior at high temperature for the models of building behavior.

Figure 7. Reduction of yield strength of steel from the room-temperature value with increasing temperature. Solid curve is structural steel. Dotted curve is characteristic of the high-strength bolts from the towers. Building fires can give rise to steel temperatures in the 500°C–700°C range.

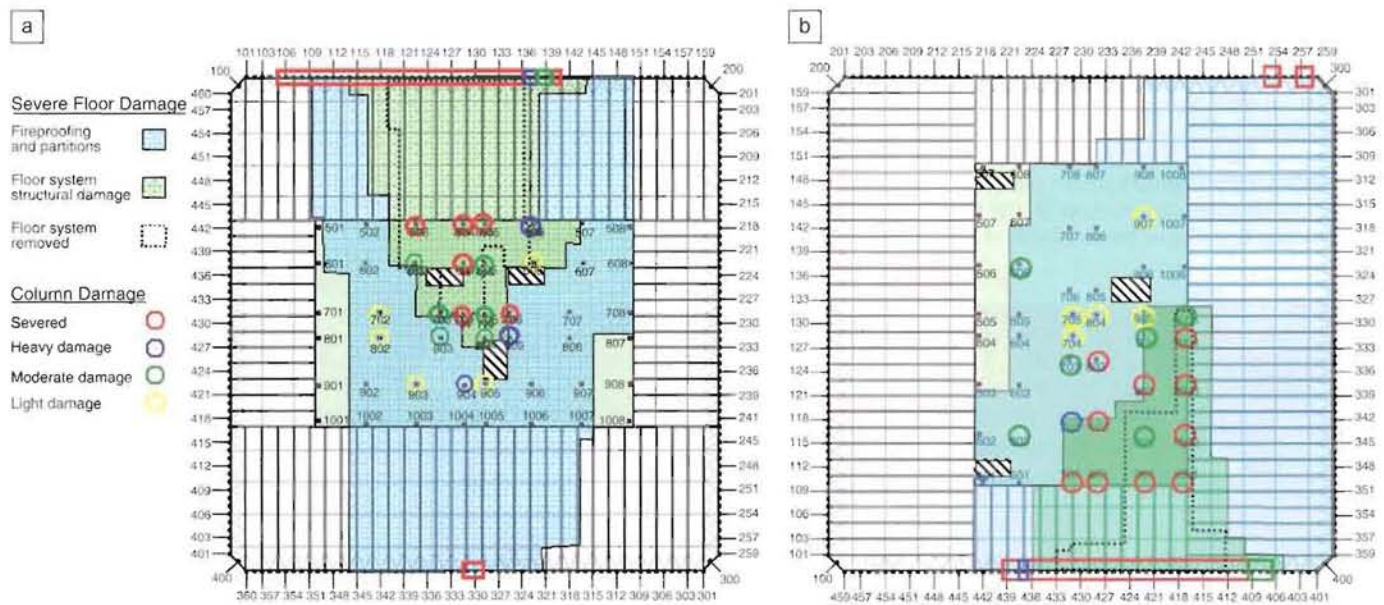
Figure 8a summarizes the type and extent of damage to floors 93–98 in the North Tower. The fireproofing material was dislodged from a large area inside those floors, because it was never designed to withstand such an impact; without fireproofing, the steel heated up rapidly and lost strength. Also shown is the number of core columns that were severed, according to the modeling results. A notable feature of these particular floors in the North Tower was that the stairwells were clustered fairly close together. The building codes at the time of construction specified that stairwells should be spaced as far apart as practical, but "practical" was left undefined. In this case, they were fairly close together and were severed by the impact so that no one above the impact could exit through them.

The fires were worse on the south side because the consumables were bulldozed into that section. When the steel heated up, the core columns and the 60-foot floor trusses started to lose strength; they sagged and pulled in on the perimeter columns on the south face. Shortly before collapse, the columns were observed to be bowed about 40–55 inches in one area. Eventually, the columns buckled, and the

Figure 8b shows the computed damage done by the airplane in the South Tower.

Figure 8. (a) Cumulative aircraft impact damage to floors 93 through 98 in the North Tower. Aircraft entry was from the north (top of image). The stairwells (hatched rectangles) were clustered close together in the impact floors of the North Tower, and all were impassable to occupants above the impact. Note the extended range of damage to the fireproofing; computer models indicate that if the fireproofing had remained intact, the fires would not have led to collapse of the buildings on September 11, 2001. (b) Cumulative aircraft impact damage to floors 78 through 83 in the South Tower. Aircraft entry was from the south (bottom of image). Structural damage was more severe than in the North Tower, since a massive corner column of the core of the building was severed as well as other nearby columns, making it difficult for loads to redistribute to sound columns. Note that the stairwells (hatched rectangles) were spaced far apart; the stairwell in the northwest corner of the core (upper left) was damaged but remained passable through the impact floors.

The area in blue represents the extensive damage to the fire protection. Some core columns were torn out completely and the others sustained moderate damage—and it was very asymmetric damage. The stairwells in the South Tower were well spaced at this level, and at least 18 people above the level of impact managed to get down the stairwell in the northwest corner of the core. Also, there were relatively few people left in the upper floors of the South Tower at the time of impact, since after the North Tower was struck, many had reached the lower floors using the elevators.

Much of the consumable material that fueled the fires was bulldozed toward the northeast corner. The east face supported the 60-foot floor trusses. Quicker than in the North Tower, just 18 minutes after impact, the columns were obviously bowing in, about 10 inches at this point in time. Shortly before collapse, the bowing was about 20 inches. Then, just seconds before collapse, there was a very obvious inward bowing of the columns. As in the North Tower, the columns buckled and that instability again propagated, across the east face, and the building came down.

Of the major factors that led to the collapse, it appears that the dislodging of the fireproofing from the trusses and columns was the most critical. If the fire protection had stayed on, the NIST models suggest that the buildings would have stood indefinitely. Manufacturers are currently working on developing new fireproofing materials with better adherence properties.
