The Collapse of the World Trade Center Towers: A Metallurgist's View

Frank W. Gayle

This article is based on an edited transcript of a presentation given by Frank W. Gayle (National Institute of Standards and Technology) on April 12, 2007, in Symposium X at the Materials Research Society Spring Meeting in San Francisco.

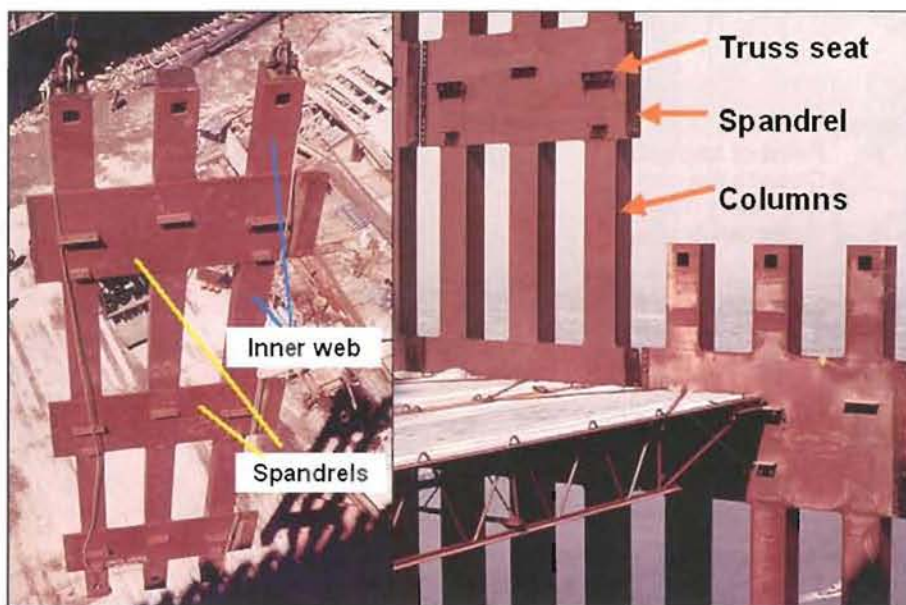
Figure 1. Modular, prefabricated perimeter panel and floor truss structures during construction of the World Trade Center Towers. Perimeter panels are 10 feet wide by 36 feet high. Perimeter panels, three columns wide and three stories tall, were hoisted into place and bolted to adjacent panels. Floor panels, typically 20 feet wide and 35 feet or 60 feet long, were then positioned onto the truss seats. (Photo source unknown. Enhanced by NIST.)
